Site Inspection comments:

Date: 27.08.2015.

Place: Golaghat S.C.Division, Dhansiri S.C.Range, Sarupathar

A. Golaghat-3, Langthajan IWMP & B. Golaghat-2, Gelajan IWMP

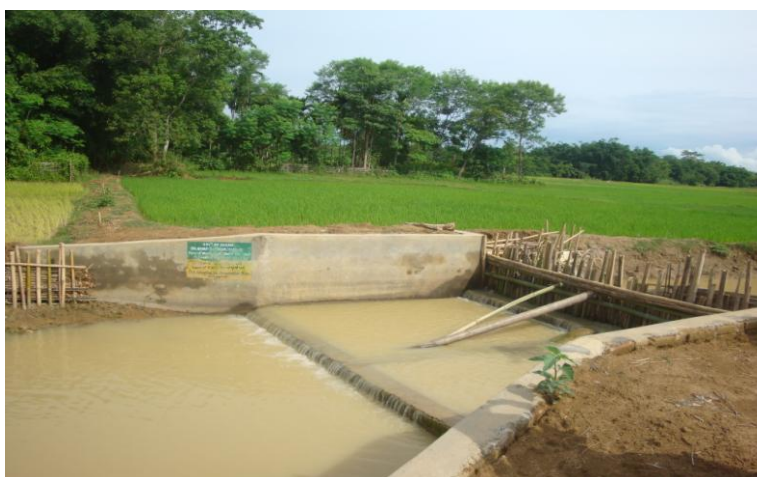
1. Masonry Stop Dam at Sonalipathar village, Sonalipathar MWS : The constructed check dam is serving the purpose of retaining water for surrounding paddy fields though the farmers had to extend the height of head wall by providing bamboo barrier on head wall.

The design mentioned in the estimate copy is not adequate for a structure made of brick masonry instead of R.C.C. structure. Brick walls without reinforcement cannot withstand the same water pressure as R.C.C. walls of similar dimensions. For example – the proposed head wall with a height of 1.50m, length of 6.00m and thickness of 0.40m is not adequate to withstand the pressure of water for long period. The Side Walls shape is not maintained as per design. The earthworks around the structure was not completed. The head wall height is not maintained as per design. In the estimate Apron calculation is not included. The work was not finished completely.

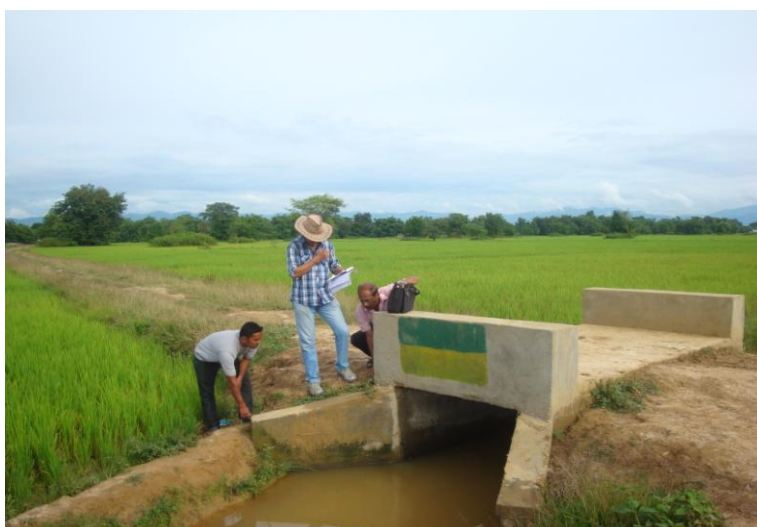
2. Nalla Bund with Slab Culvert at Amguri No.1 village, Amguri MWS : The objective of the slab culvert as well as the Nalla Bund is fulfilled as it is allowing excess water to pass through it easily. The quality of the construction looks good. The work was not finished completely.

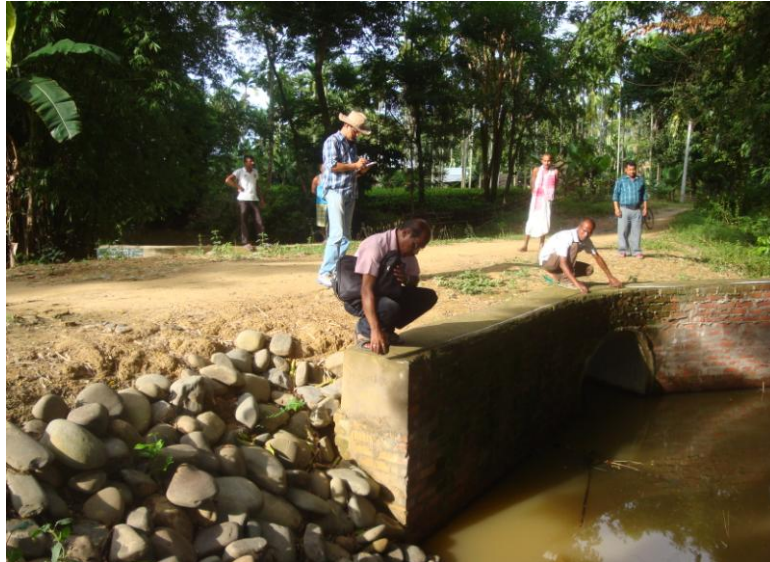
3. Boulder Bank Pitching with Hume Pipe at Holowguri (Borhula), Borhula MWS : The size of the Hume pipe culvert looks less than required for the width of the drainage line, two rows of hume pipe would have been adequate . Boulder pitching is done without wire crate as mentioned in the estimate. The work was not finished completely.

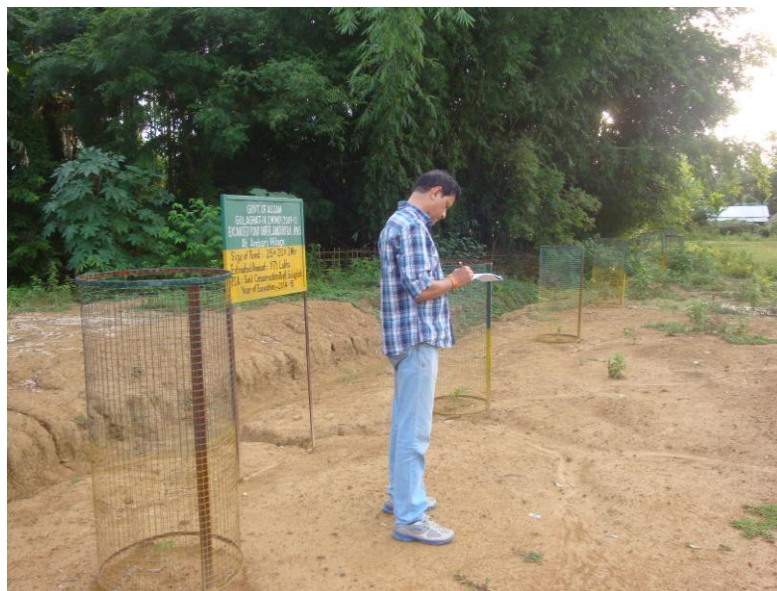
4. Road Side Plantation at Ambari village under Janatapathar MWS : The Plantation was done properly with Iron enclosures. Total of 57nos of plantation done.

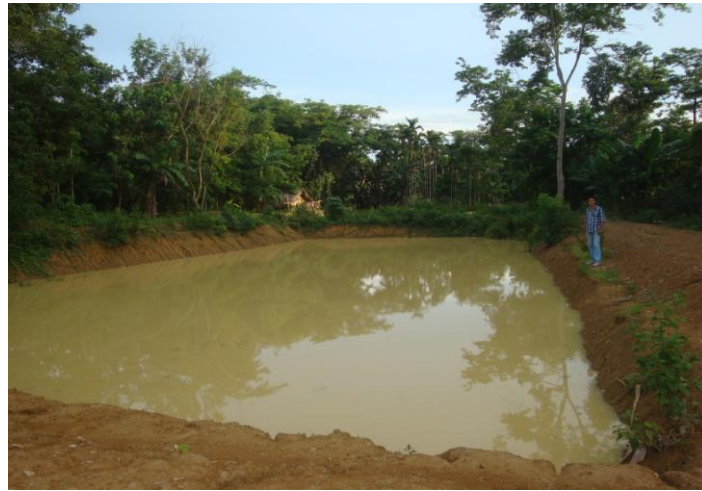
5. Excavated Pond at Ambari village under Janatapathar MWS : The pond was excavated as per as per estimate and will serve the purpose for the user group.

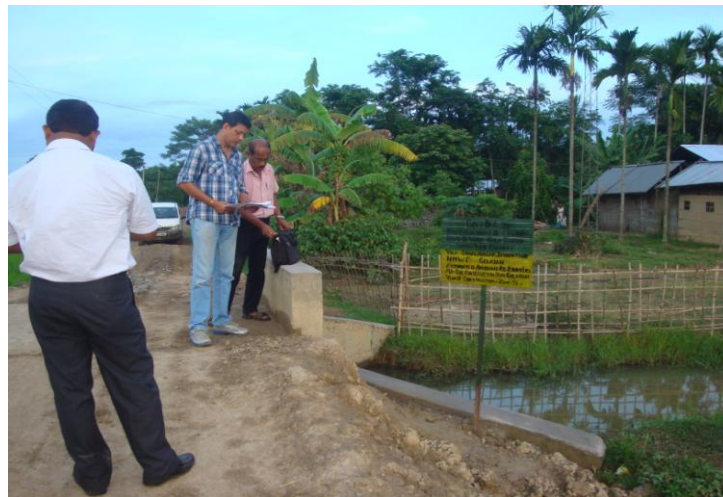
6. Nalla Bund with Slab Culvert at Sonalinagar village, Gelajan MWS : The R.C.C. part of the project was finished it was contributing to easy flow of excess water from the area. The earthwork part and the boulder pitching part were not finished. The earthwork part for Nalla Bund seems to be overlap with the excavation of drainage channel nearby.

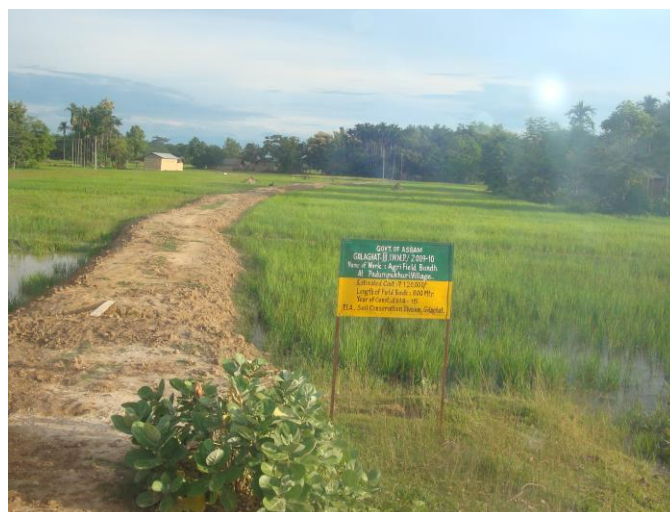
7. Agri Field Bund at Padumpukhuri village, Padumpukhuri MWS : The Agri field bund work was not finished. It was advised to complete the work by maintaining the side slope and the depth of filling.
